Navajo Abandoned Uranium Mine Site Screen Report

Glover AUM Site

Navajo AUM Eastern Region

May 2009

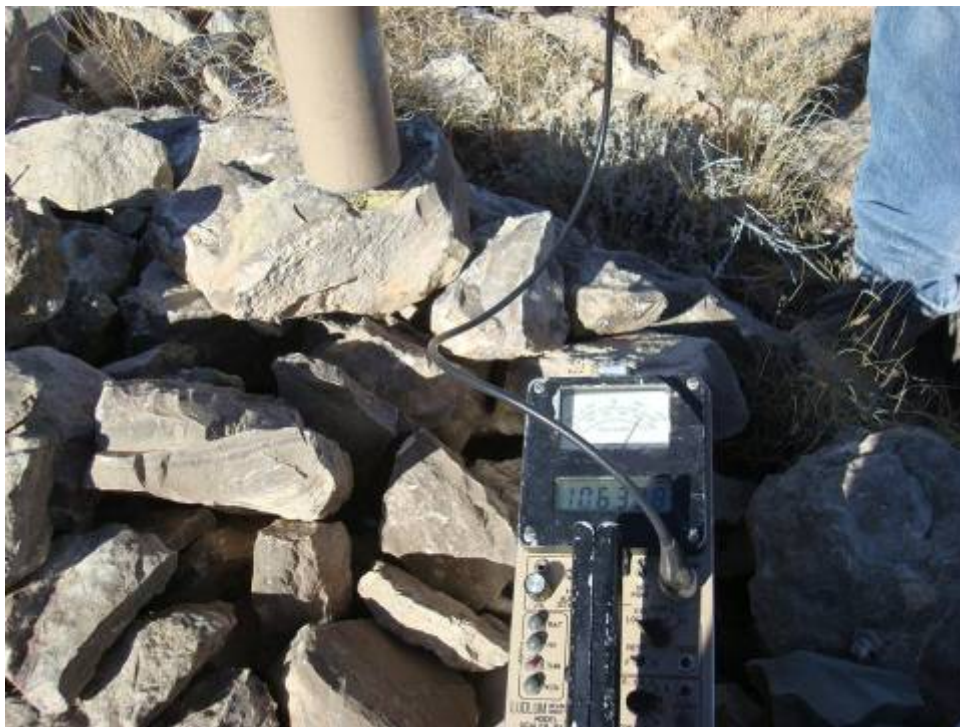
Photo 4. Glover Mine site, waste rock piles

Reclamation status of the mine sites are currently unknown. No visible signs of reclamation were observed. The mine is located on top of a mesa. Piles of waste rock are located through out the mine area. No adits, or other mine features were observed during the site visit.

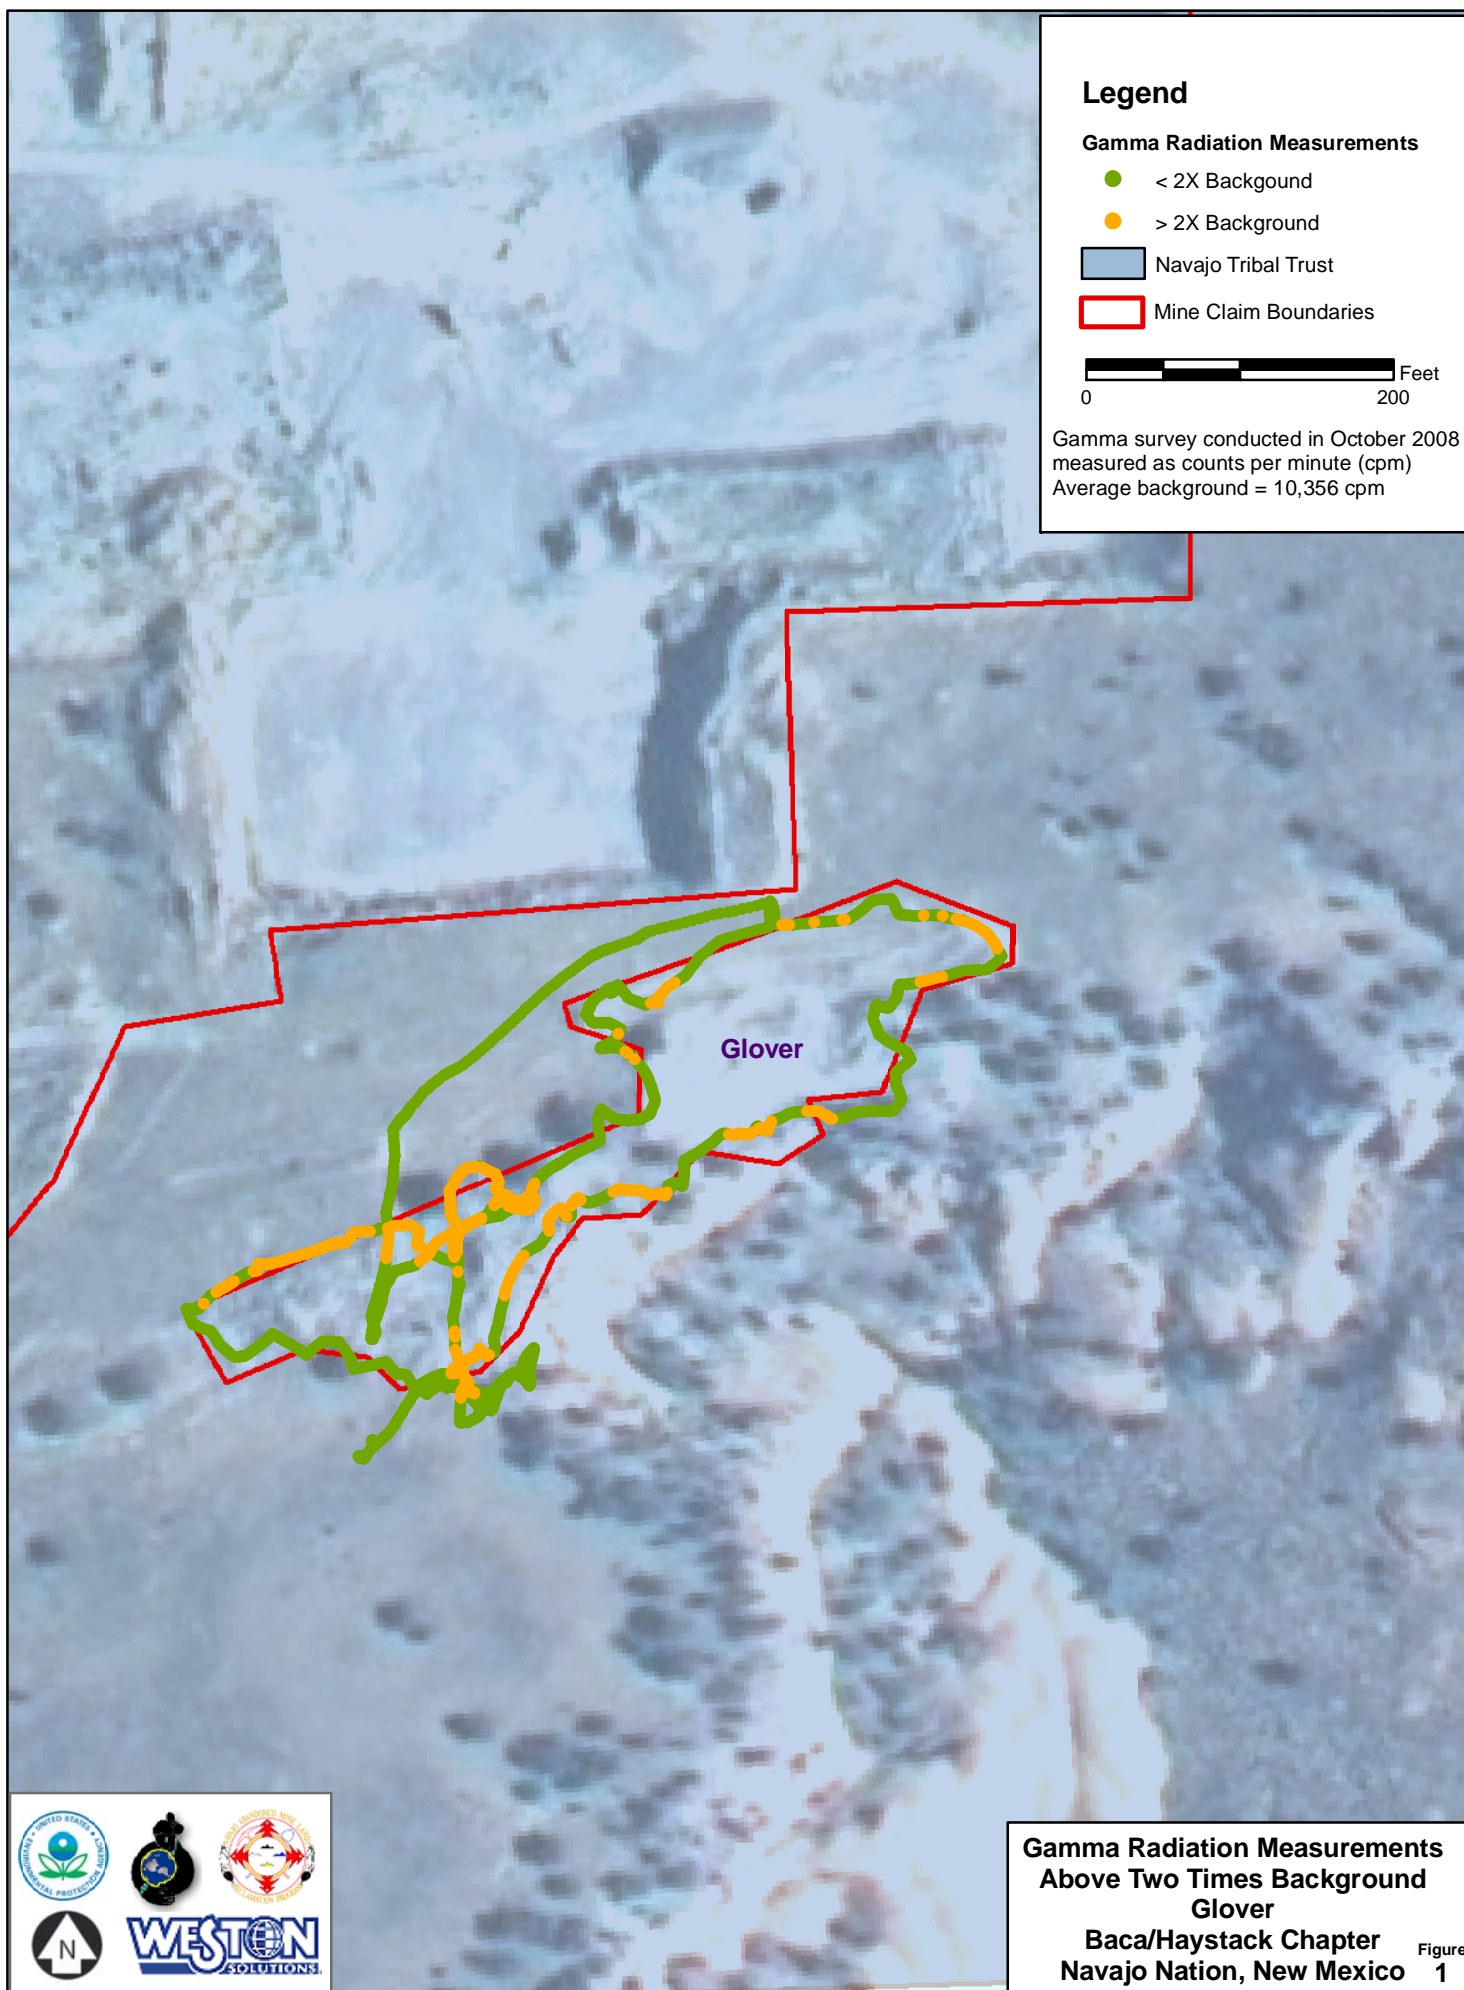
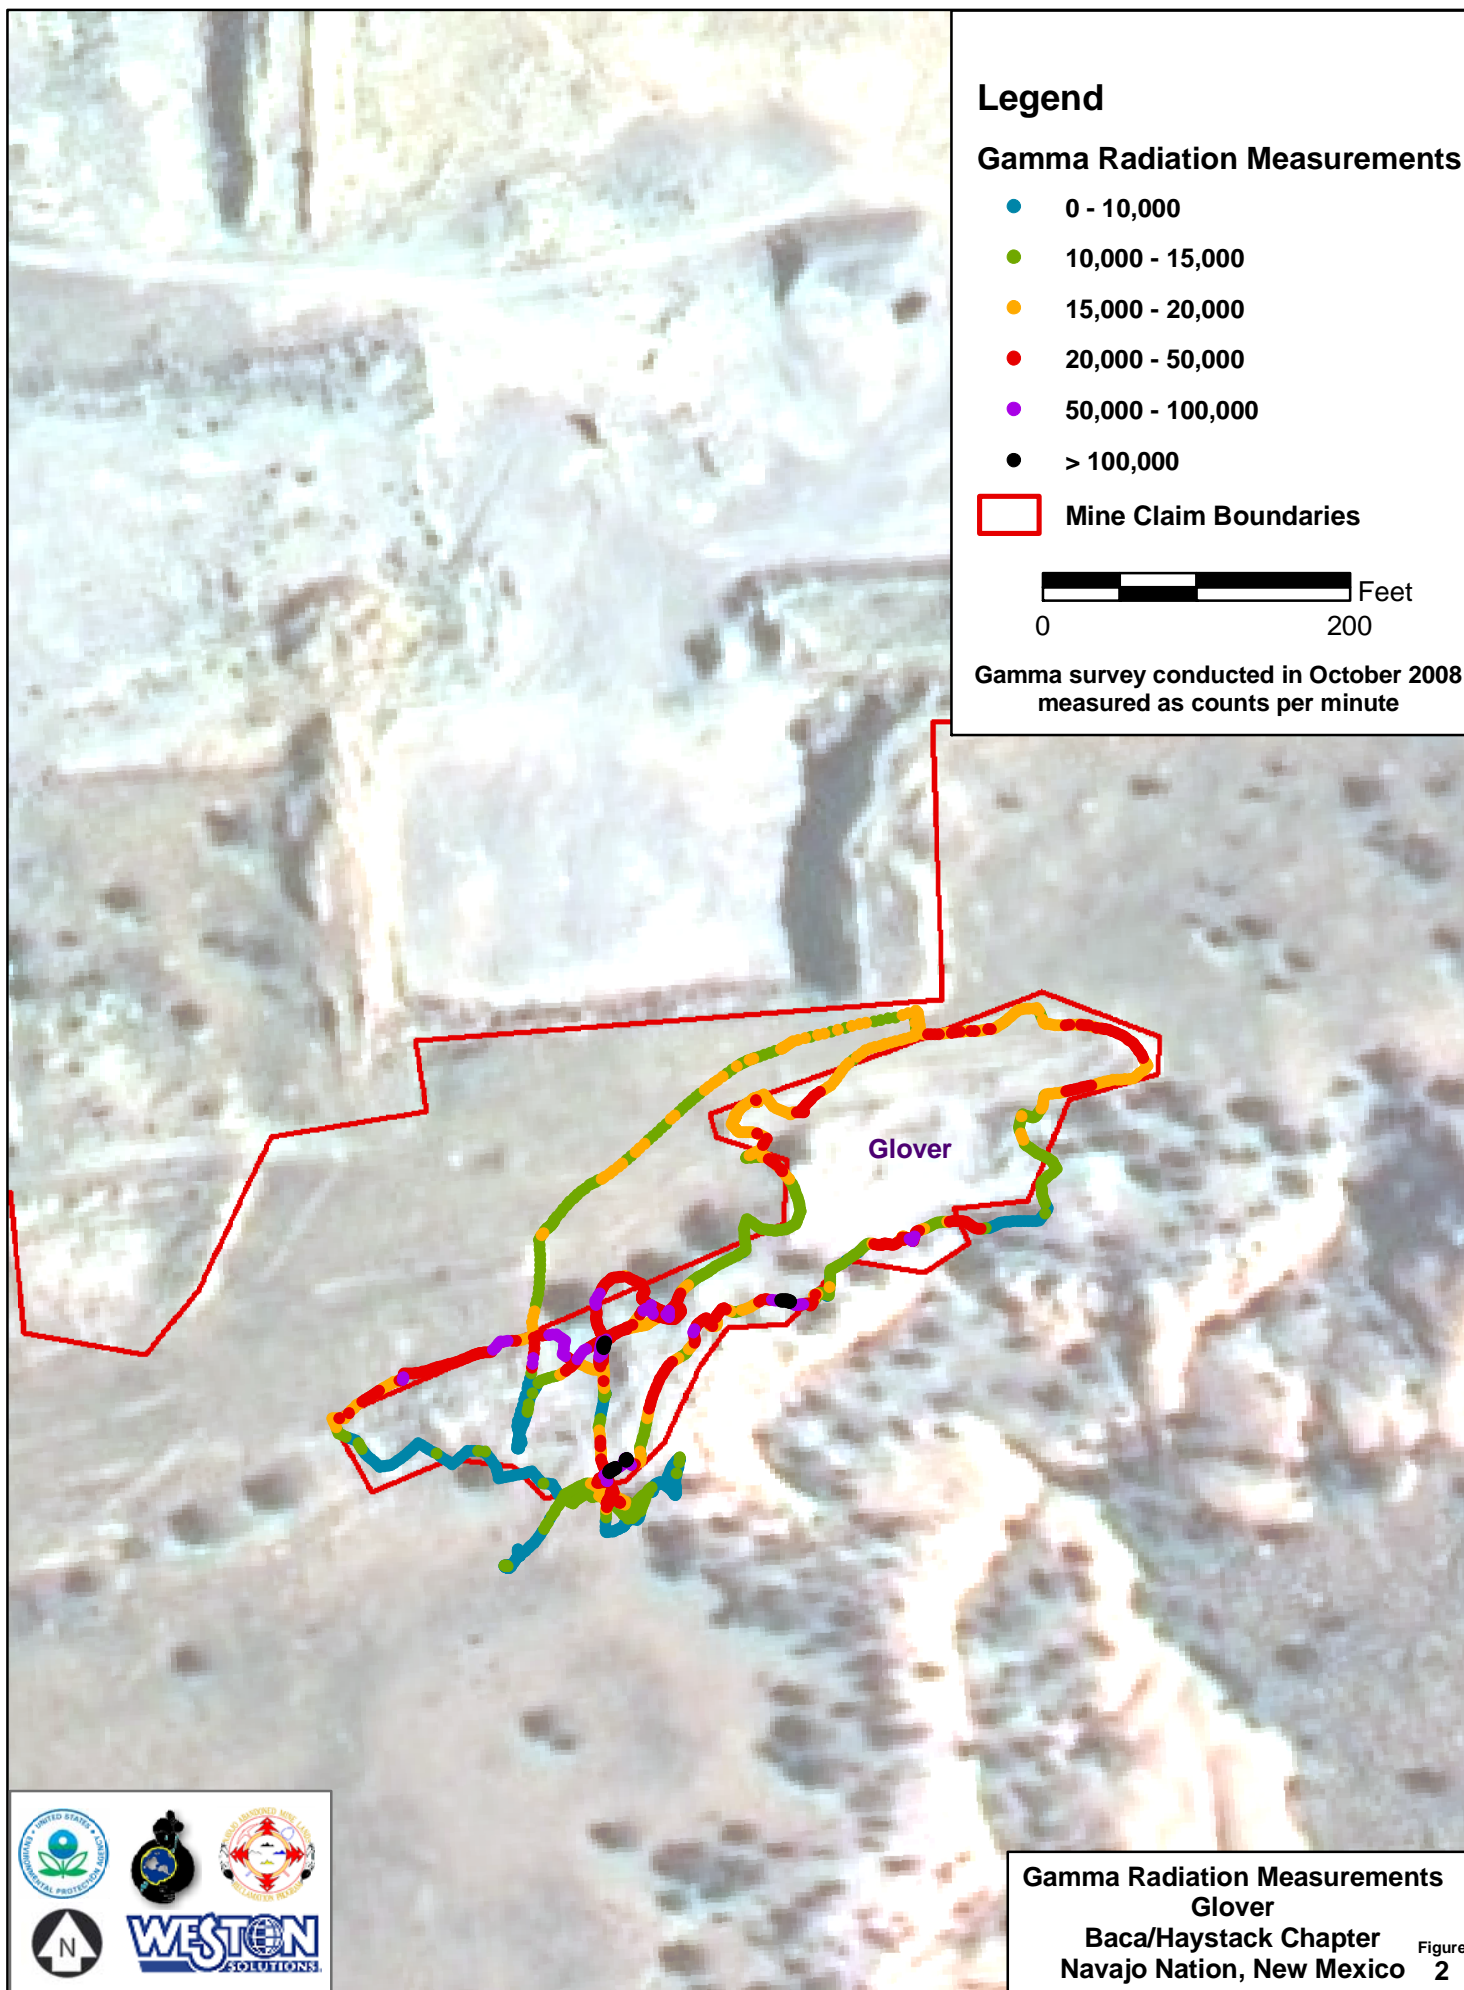
- See Figures 1 and 2

A total of 3,228 gamma radiation measurements were collected from mine sites, ranging from 6,197 cpm to 144,738 cpm. The measurements are represented in Figures 1 and 2. Radiological measurements collected for the New Mexico Mining and Minerals Division during a 2008 field screening survey found gamma radiation levels near the ground surface with a maximum of 140 micro Roentgen per hour ($\mu\text{R/hr}$) and a minimum of 10 $\mu\text{R/hr}$, levels at the 4-foot elevation with a maximum of 680 $\mu\text{R/hr}$ and a minimum of 8 $\mu\text{R/hr}$, and background levels of 10 $\mu\text{R/hr}$.
